GIS technologies in icing on power lines analyses

Sergey CHERESHNYUK¹, Alexander MERZLYAKOV¹, Svetlana KAREVA¹

¹ *Research and Development Centre at Federal Grid Company of Unified Energy System (R&D Center @ FGC UES), Russia*

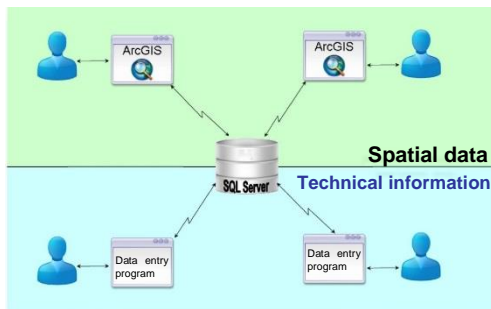
Figure 2 – Scheme of GIS-project

The authors developed a GIS-project which has the spatial database in its basis (based on SQL Server) (Figure 2). For visualization of the spatial information was used ArcGIS. Moreover, there was developed the software application in the project to put technical information and operating experience into the database.

Figure 1 shows a scheme of the interaction between users and the system developed in the GIS-project. The whole information (spatial, technical and the operating factors) is stored in one relational geographical database, located at MS SQL Server. ArcGIS ArcMap was used for the spatial data analysis (the substations location, towers and spans of OHLs). The technical characteristics of a line (passport information, design loads, the parameters of the wires, cables, nonconductors, towers, and other elements of OHL), together with operating data (accident records, types of defects, etc.) are written into the database in the developed application. The statistical assessment and data analysis of the OHL was done in separate application.

The database includes two types of tables: the ones which content spatial and technical information and the others which content only technical information. The main tables which content spatial and technical information are:

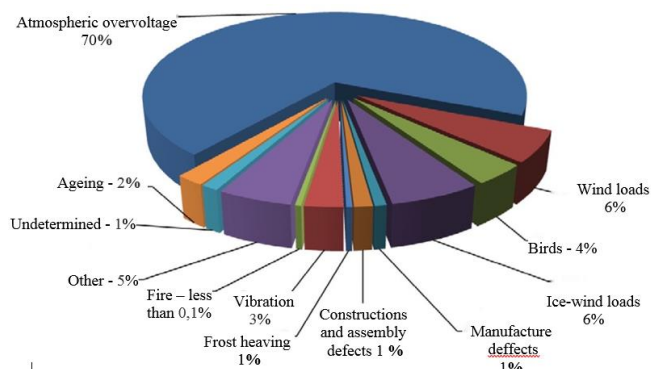
Figure 3 - Distribution of the technical break-downs by their causes

Figure 3 shows the distribution of the technical break-downs by their causes.

As one can notice in the figure 2, the main reason of the lines cut-downs is lightning overvoltage. Their number in this territory reaches 70% of all the cases under investigation. It's worth noting that although ice heaving caused only 1% of all the cut-downs, it does not mean that this issue is not relevant for the area under investigation. The analysis of the examination records, records of damages and the records of work done at overhead lines revealed 3582 cases of the heaving of the base tower polling from 2010 to 2016.

As it can be seen from fig. 3 ice and ice-wind loads are the cause of only 6% of total accidents. This is because this region does not characterized by high ice loads. Wet masses from Atlantic "loose" their water supply in the European part of the continent. Remains of water are stopped by Ural Mountains. Indeed climatic maps created on the base of long-period meteorological observations shows that for the territories with the same absolute height and geographical conditions but located one in the European part, before the Ural mountains and second after Ural mountains in Asian part of the continent the maximum equivalent radial ice thickness having return period of 25 years differs two times (25-40 vs. 15-20 mm)! So, air masses, already poor of water, coming to this vast, open territory of West Siberian plane, from west or north do not face here any relief obstacle and do not leave here any considerable ice loads.

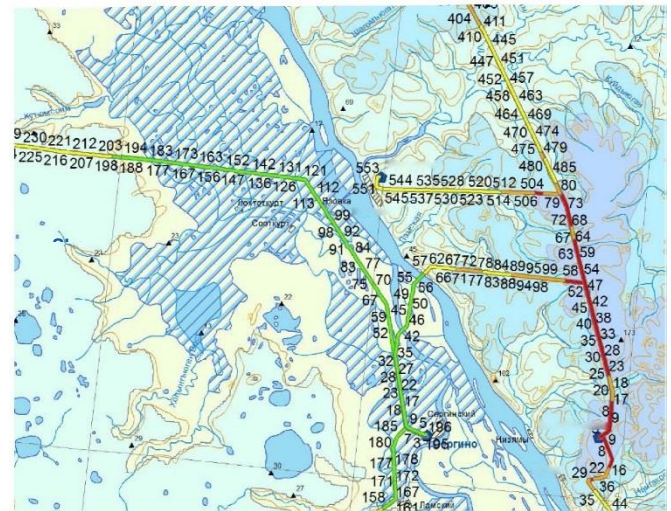
Figure 4 - Comparison of the design climatic loads of the operating lines 110-220 kV with the requirements of modern climatic maps.

Figure 4 shows the comparison of the design climatic loads of the operating lines 110-220 kV with the modern requirements. As one can see from the figure 4, some parts of the line correspond modern requirements (in green), and some

parts had a considerable rise in climatic loads (depending on the level of the loading rise, these parts are marked in color ranged from yellow to red). The specific level of ice and wind loads rise can be found in the corresponding tables.

It was found after the analysis of the line shut-downs connected to the ice and wind loads, in addition to the comparison of design climatic loads with modern requirements that the causes of many of 110 kV OHL shut-downs are connected to the climate change or to the fact of our better understanding of climatic conditions in that region.

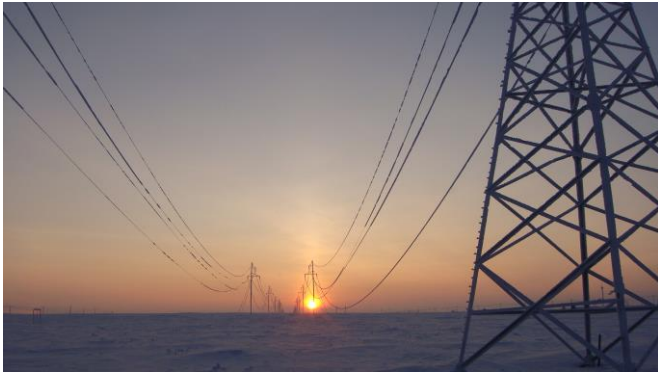
Figure 5 – Icing event on the north of the region on January 2016.

One of these episodes has took place in January 2016 when wet and relatively warm air masses from North Atlantic has reached this territory. Weight of hoarfrost icing was more than 1100 g per linear meter, which is 11,6 mm of equivalent radial ice thickness ($0,9 \text{ g/cm}^3$). For OHL constructed on equivalent radial ice thickness of 5 mm it meant exceeding design load of 2 times.

Some photos of that case are shown below (fig. 5, 6).

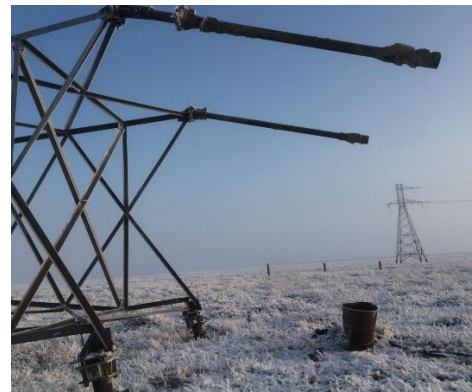
Figure 7a – Tower fall with the bases plucking out of the ground (October 2016).

The impact of the frost heaving forces and the bases deformation worsen line operating conditions, cause damage to its constructional elements, and lead to high annual costs for the line elements repair works. The photos of the figure 7 show different cases of the tower bases heaving and their effects for the line operation.

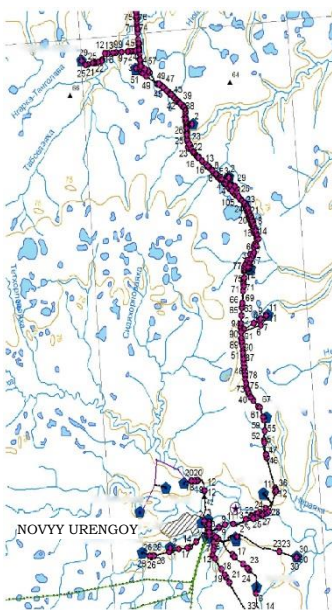
Figure 8 – Mapping of cases of frost heaving of piles of towers

For example, the figure 8 shows the spatial distribution of the frost heaving cases of the line 110 kV UGP-2V - Buran (in violet). The cases of the frost heaving are documented almost on all the towers during the period of 2010-2016 on the map. This is directly related to the continuous spread of permafrost in this region and the presence of a layer of seasonal thawing, in which the processes of frost heaving are developing.

The cases of the frost heaving were mapped onto geographical bases by means of the GIS-project for the spatial analysis conduction. Their biggest number was documented in the North of the region, specifically, on overhead lines near Yamburg and Noviy Urengoy.

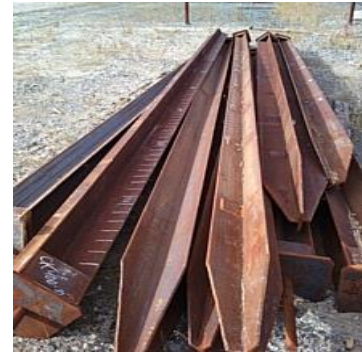
Figure 9 – Cross piles

- Rearrangement of towers to surface foundations on terrain with an even relief (without slopes, hills, etc.);
- Control of design length of the base (normal length should reach the layer which is not imposed to the seasonal melting);
- Reinforcement of towers by different methods;
- Use of bases of metal piles open profile cruciform section (Figure 9).
